Project Profile

Critical Piping Component, Clam Fishing Fleet

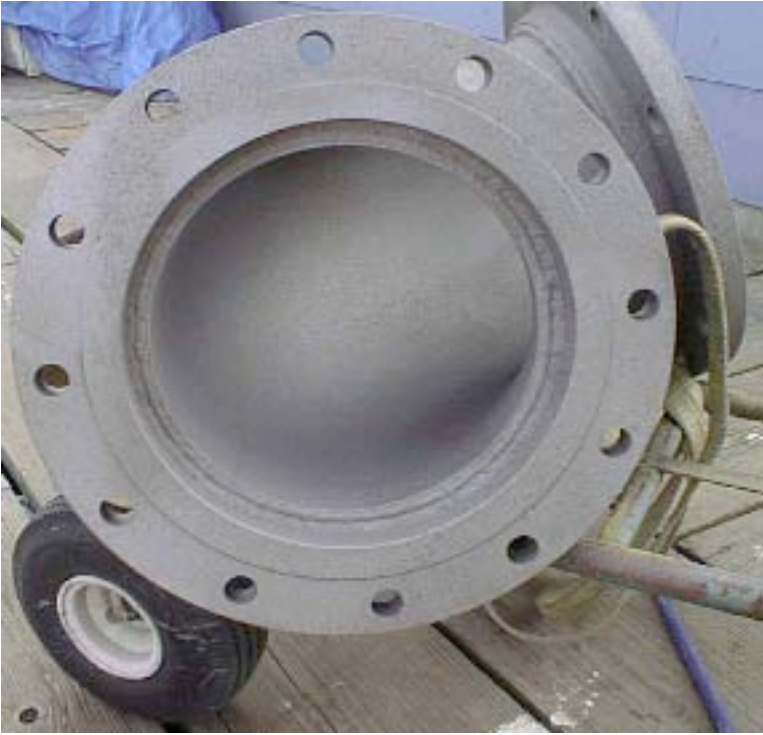
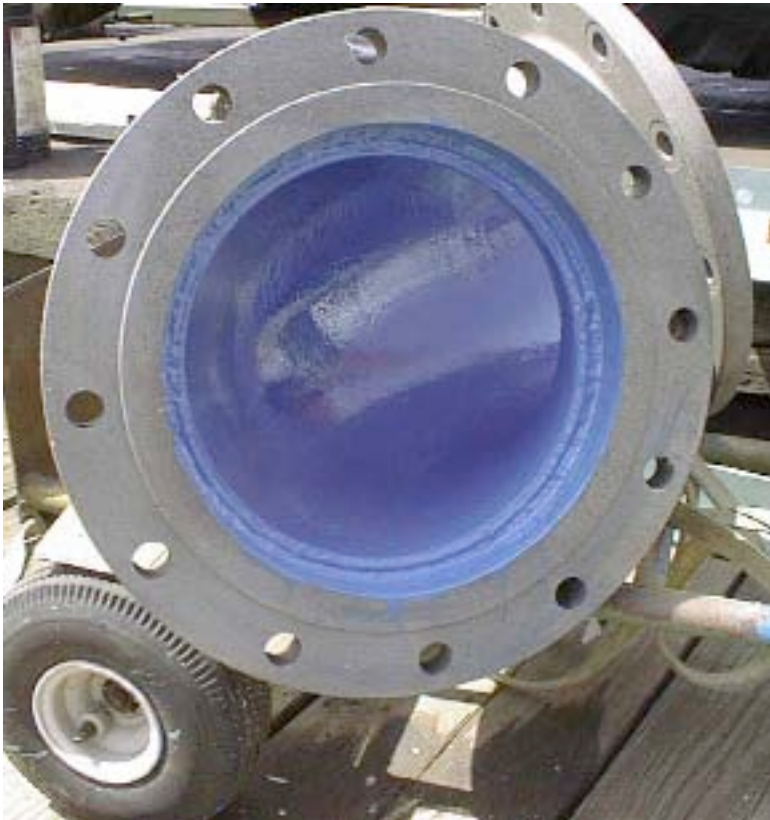
The owner of the largest clam fishing fleet in the Eastern USA approached **ADVANCED Polymer Repairs** with a problem. Certain parts of their salt water pumping system could sink a boat in minutes if they failed. Inspection required complete disassembly for visual inspection which was not fully reliable due to abrasion wearing key parts such as elbows evenly but dangerously thin. On visual inspection these components looked “OK” but could be dangerously worn. Small (1/2”) inspection ports were installed as needed. The components were coated with a high performance, ceramic enhanced system which is highly resistant to abrasion. A visual inspection with a bore scope was performed periodically. As long as the inside was a uniform blue color the pipes were 100% safe to use. Any gray spots were immediately repaired. Annual savings were several hundred thousand dollars plus peace of mind.
