Project Profile

Plastic Pipe Repair, Sodium Hypochlorite Tank

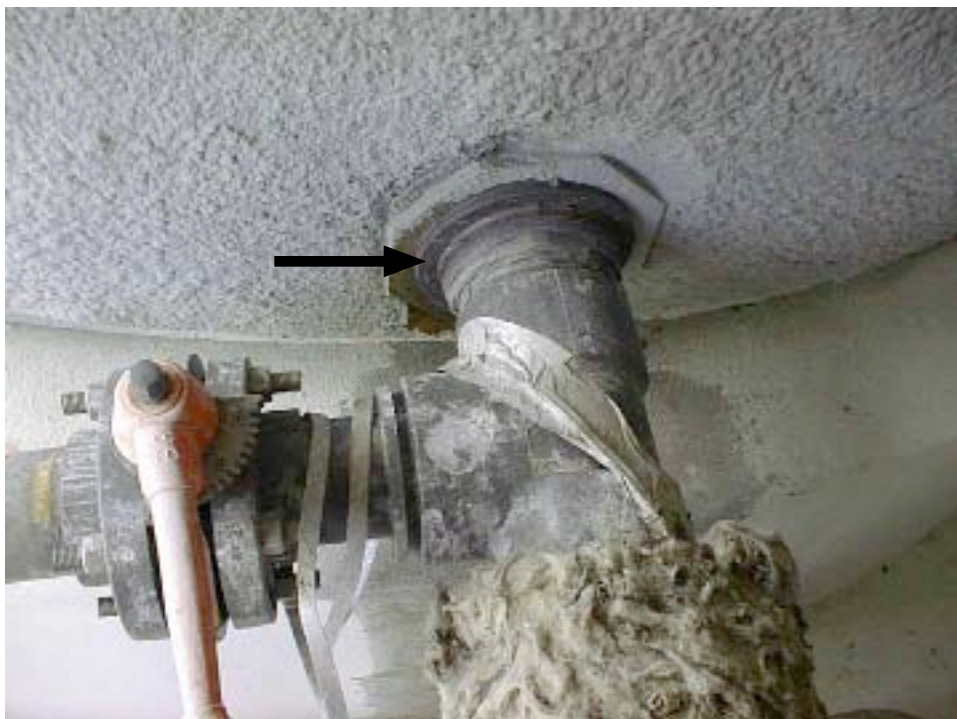
High concentrations of bleach had caused the bung threads in this 5,000 gallon tank to leak. Plastic "welding" held up for only one year. The waste water utility contacted **ADVANCED Polymer Repairs** in the hope that **ADVANCED** had a "magic bullet" solution. A high performance, chemical resistant repair system was specified.

In house staff performed the repairs in less than an hour under the experienced eye of Jim Krasnov of **ADVANCED**.

About \$50 of product saved the utility several thousand dollars in replacing the tank. As of this writing, about 5 years later, the maintenance staff reports "NO LEAKS!"
