Project Profile

Concrete Floor & Expansion Joint Repair

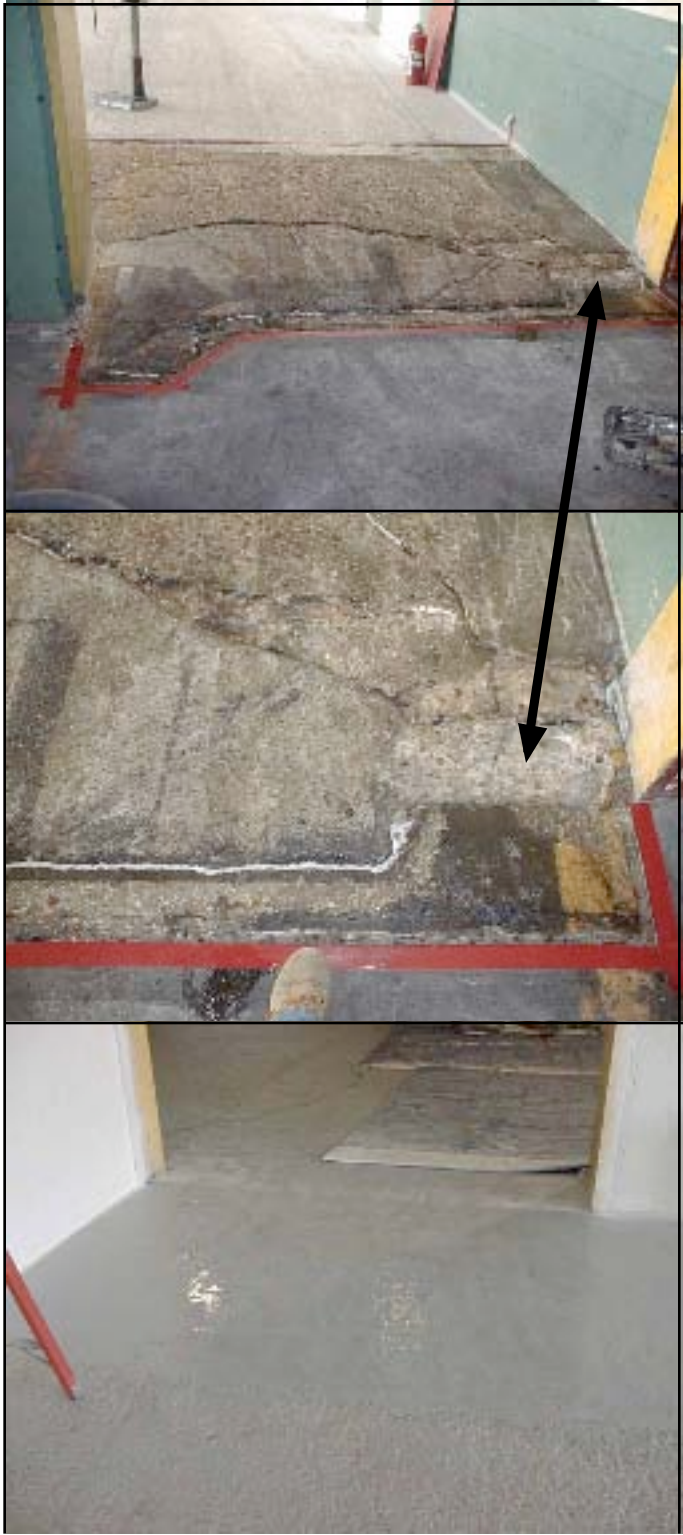
The main aisle between two warehouse areas was exposed to constant, heavy forklift traffic. The expansion joint edge started to crack and the concrete surrounding it had spalled and was failing. It was costing the property owner substantial money in lost productivity, merchandise damage along with damage to the forklifts. **ADVANCED Polymer Repairs** had a long-term relationship with the owner and was told to “Fix it”.

Working over a weekend **ADVANCED** saw cut a perimeter and saw cut the expansion joint back to stable concrete. The expansion joint and work area were repaired with a 100% epoxy system which has a compressive strength of over 12,000 p.s.i. The joint was then saw cut open and filled with a unique polyurethane expansion joint material which has excellent adhesion to concrete, can take the constant pounding of forklifts and is flexible enough to allow the joint the needed movement.
