## Project Profile Parking Garage, Multilevel

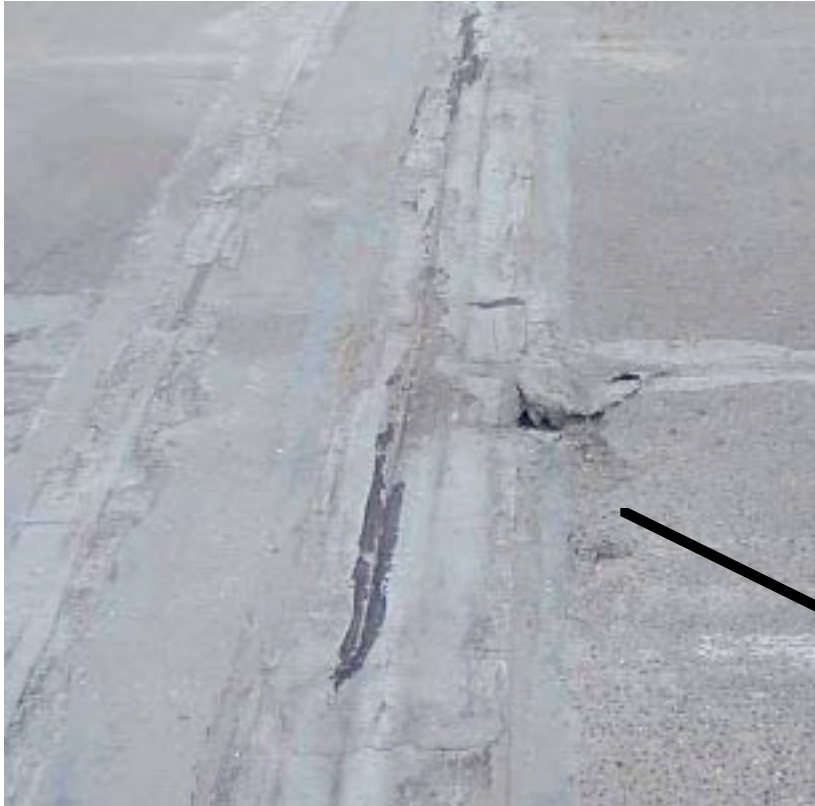
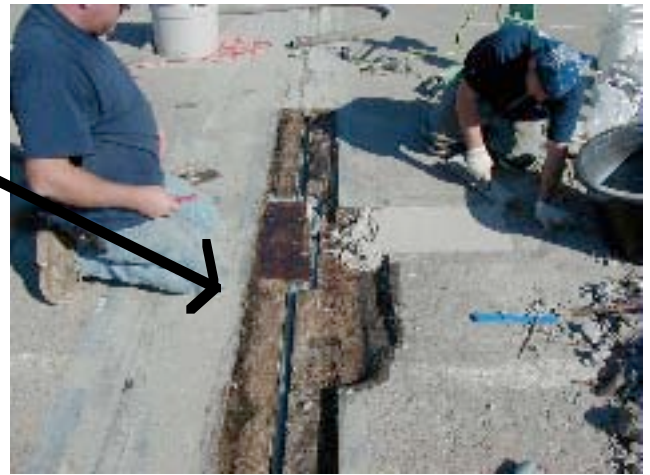
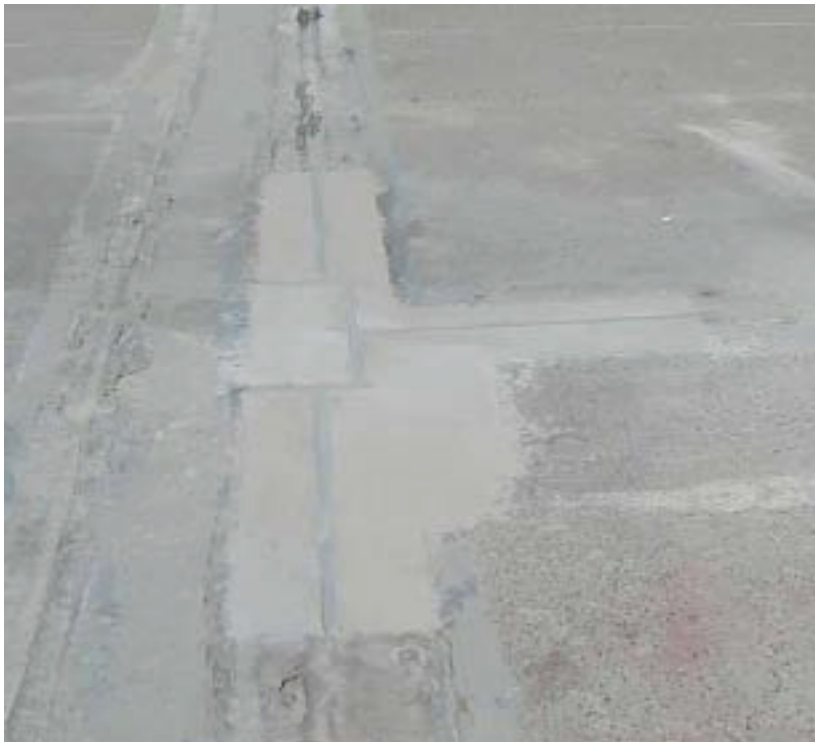
Failing concrete and cracks near the joints of this multilevel, pre-stressed design garage caused the owners to ask **ADVANCED Polymer Repairs** for help. Using a high performance concrete repair product (contains no cement or water and has 12,000 psi compressive strength) **ADVANCED** repaired the failing concrete. The joints were then filled with an elastomeric product which

has an elongation of 400%. This amount of elongation is needed due to expansion and contraction plus the normal movement of the concrete panels. The **ADVANCED** crew has the knowledge and materials required to perform long-term and cost effective repairs such as this. The materials used are also highly resistant to attack from salt and other ice removal chemicals. We have repairs which are still in good condition after seven years of high traffic use.
