# Project Profile

## Waterproofing & Coating

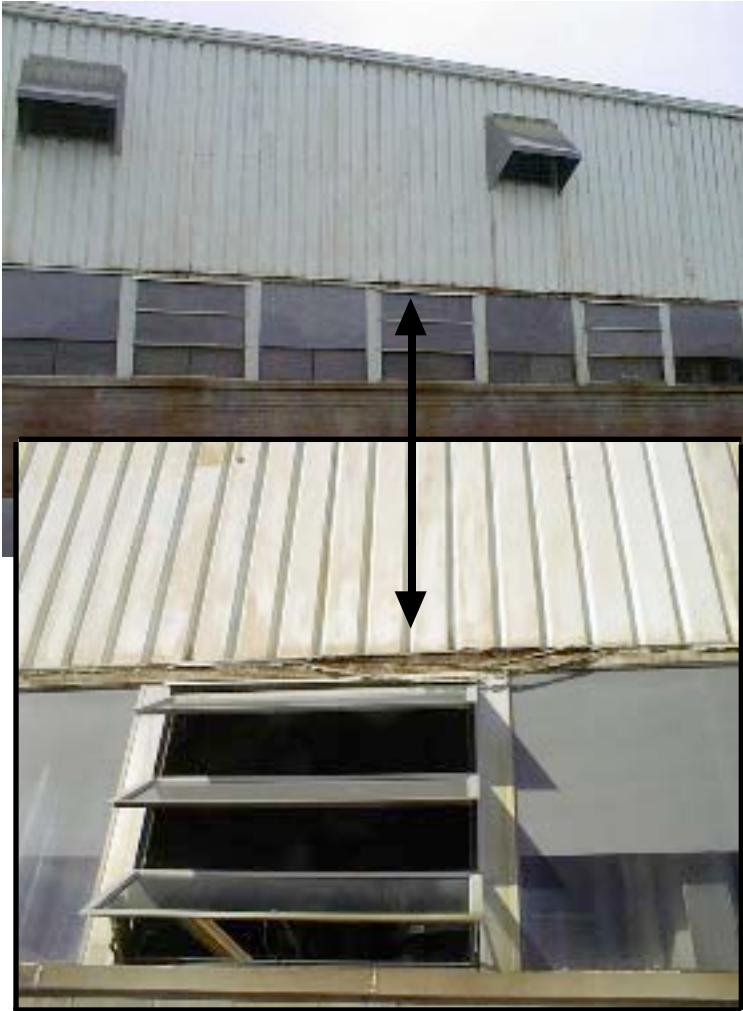
This manufacturing plant had a corroded steel facade which leaked rain water into the building due to corrosion around the windows. The **ADVANCED Polymer Repairs** team was called in because they have established a long track record of success with the building owner on other projects.

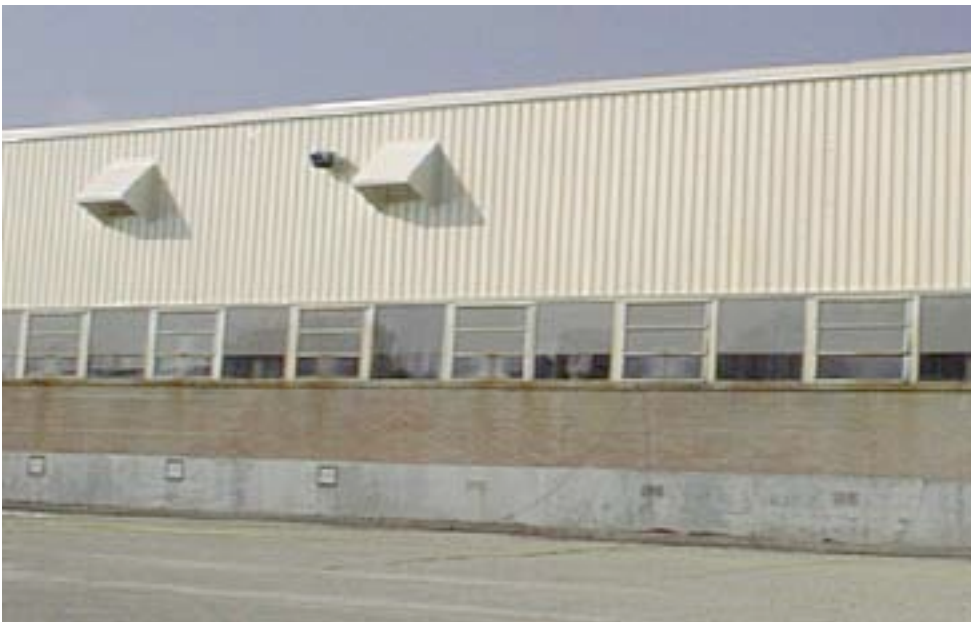
In this closeup you can see that the flashing between the corrugation and the steel window frames had rusted away completely allowing water to run into the production floor area.

The building manager said he had a dozen companies willing to paint the facade but could find no one to solve the leaking. **ADVANCED** solved the problem through knowhow and great products
