## Project Profile Corrosion in Air Handlers

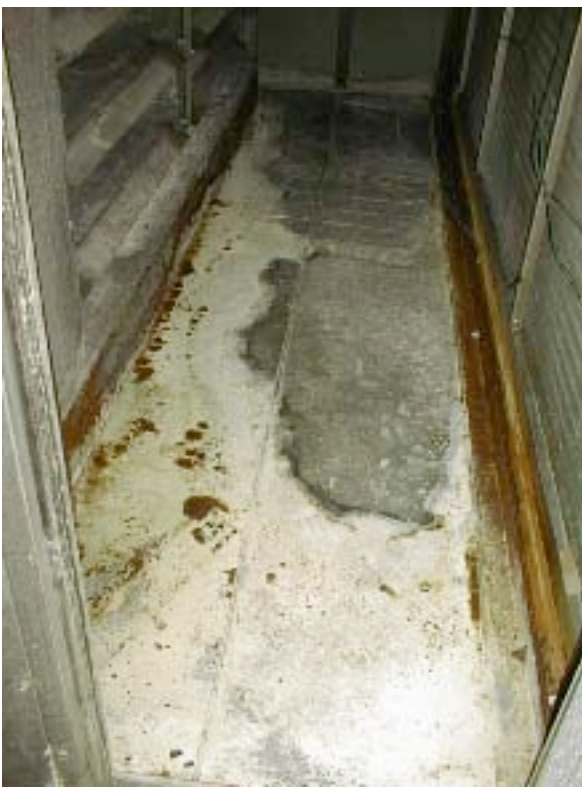
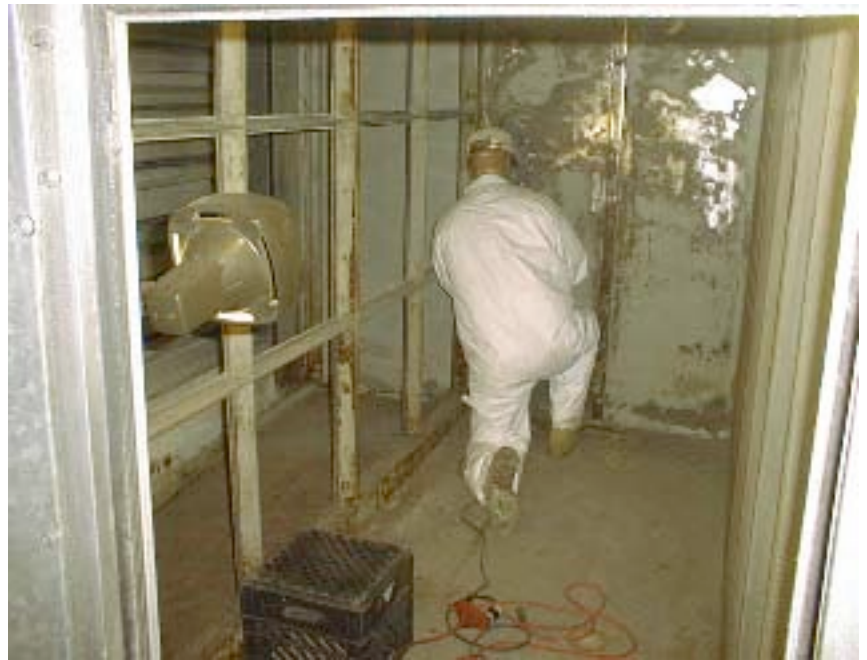
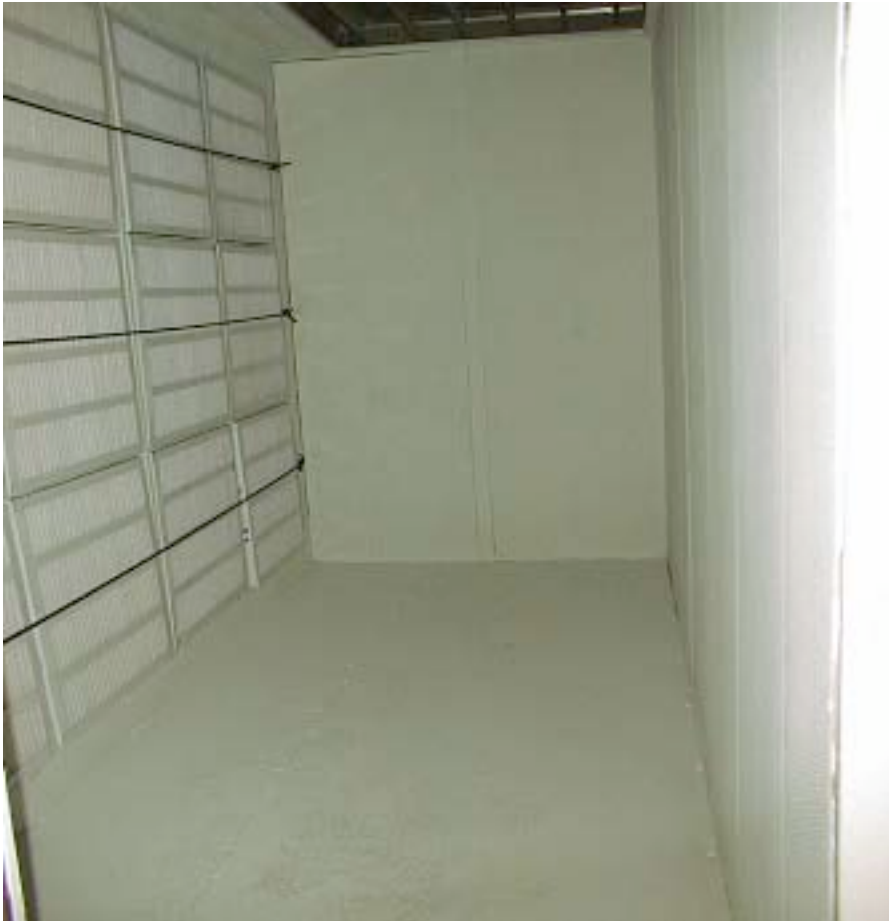
The air handlers at this Atlantic City casino had suffered severe corrosion from the salt air environment. Any coating used to effect the repair had to be extremely low in odor because of the risk of having to close the casino floor. Grit blasting could not be used for fear of dust entering public areas so surface preparation was minimal.

The problem was solved by **ADVANCED Polymer Repairs** with a highly corrosion resistant primer which would adhere to the poorly prepared surface. This was then overcoated with two coats of a flexible, corrosion resistant coating.
