Project Profile Kettle Line Repair & Sealing

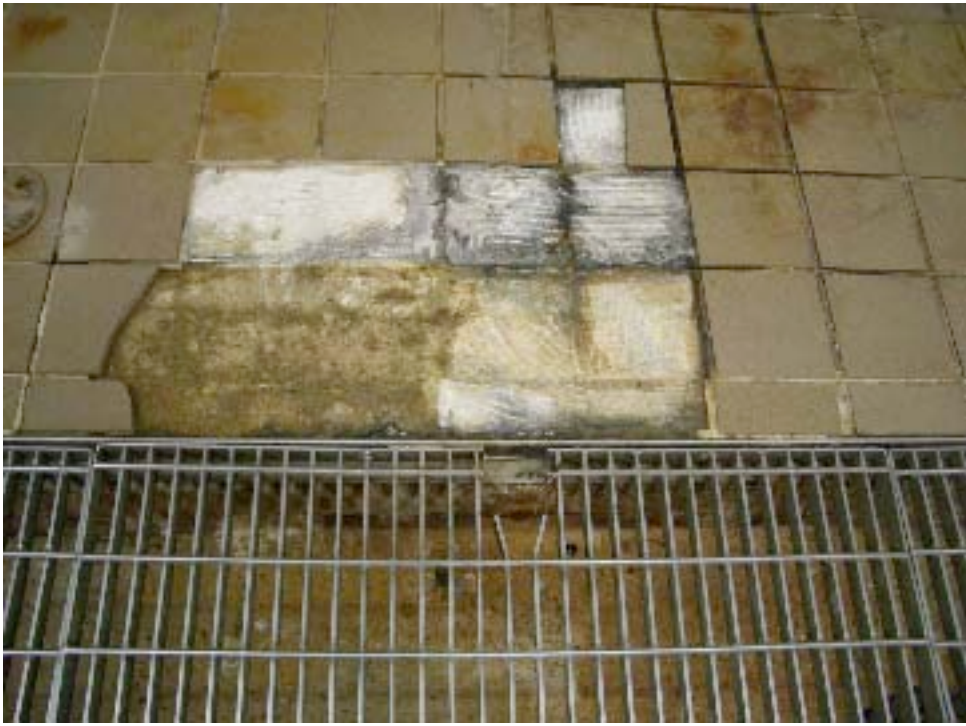
This hospital kitchen needed a permanent fix for their kettle line drain. Tile around the drain was constantly failing due to water getting into the transition between the tile and the drain. The director of facilities was tired of “fixing it over and over”.

ADVANCED Polymer Repairs was called in because of a long history of successful projects with the hospital. All of the tiles were removed along with the failing concrete. A 100% epoxy repair system was installed with an elastomeric sealer immediately surrounding the drain. This sealer is the key to a long lasting repair. The expansion joint it creates allows the drain and surrounding tile to expand and contract at their own rates when a large kettle of 200 degree water is emptied.
