Project Profile Casino Luxury Suite - Outdoor Deck

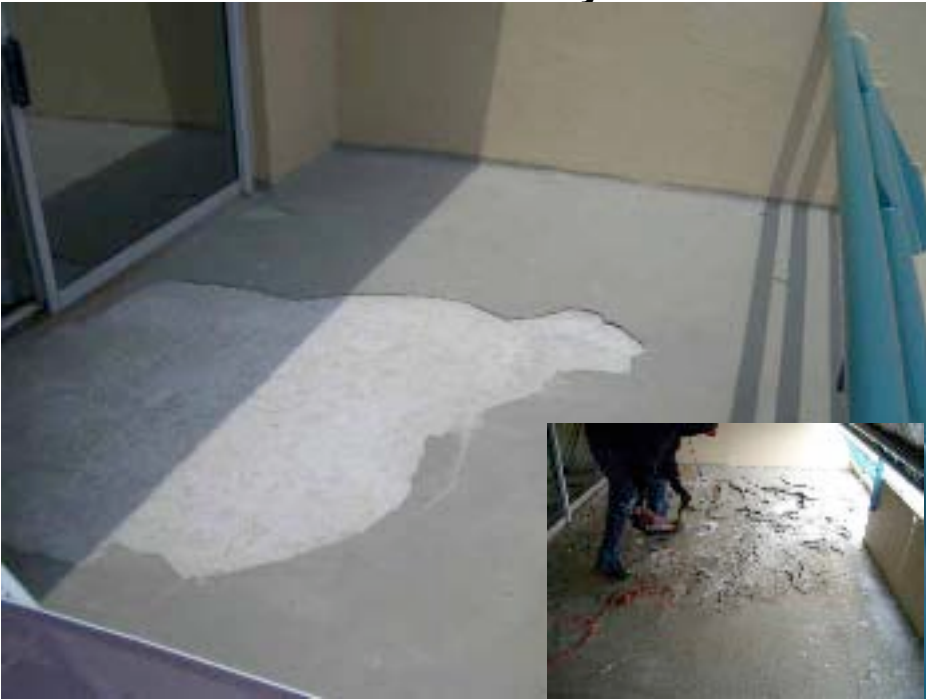
When this Atlantic City Casino deck started wicking water into the guest room

ADVANCED Polymer Repairs got the call. Over 4" of previous repairs had to be removed and a new, breathable system had to be installed and pitched to the only drain on this 250 s.f. deck.

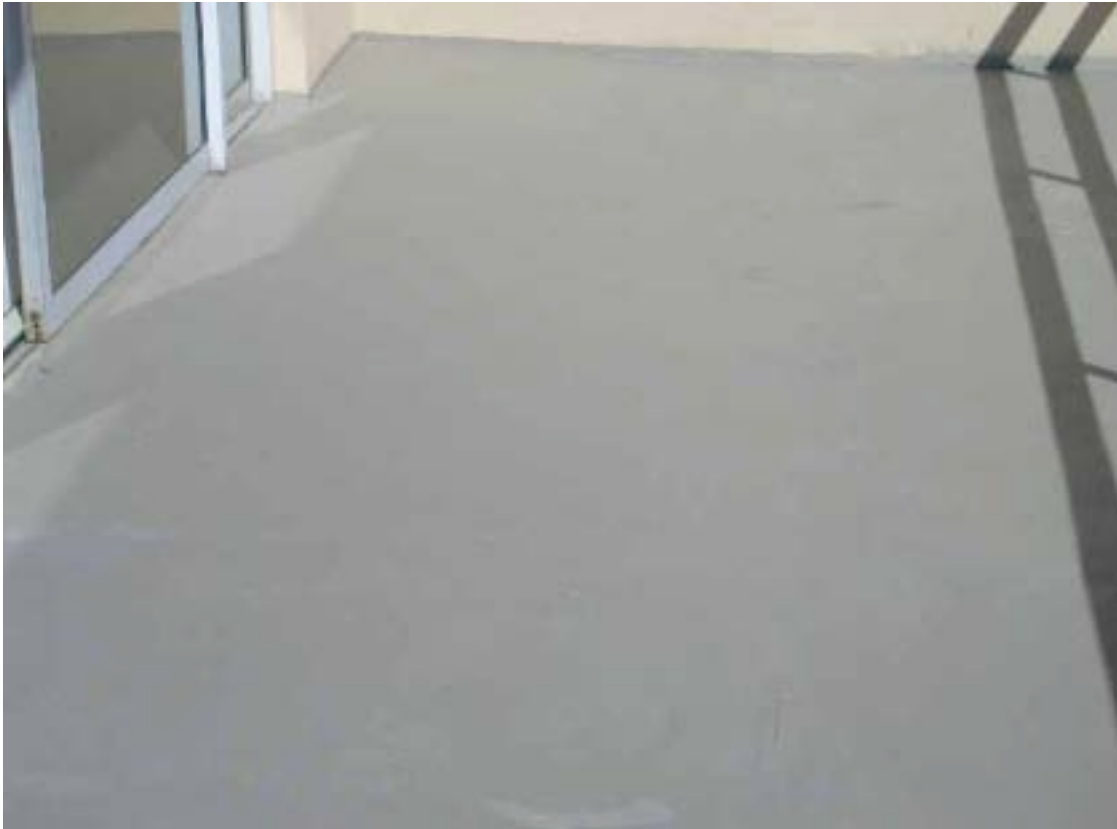
A unique and breathable system sealed the deck and allowed the water saturated concrete to dry out without damaging the repair.
