## Project Profile Outdoor Fountain Rehab

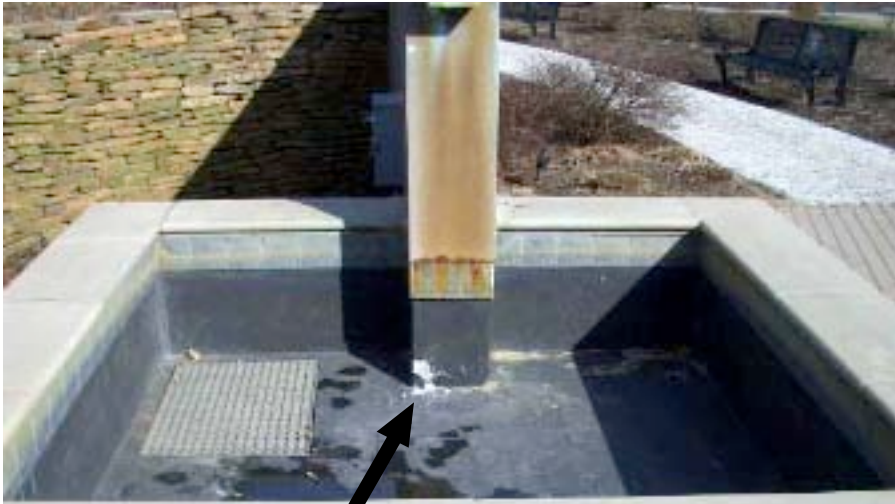
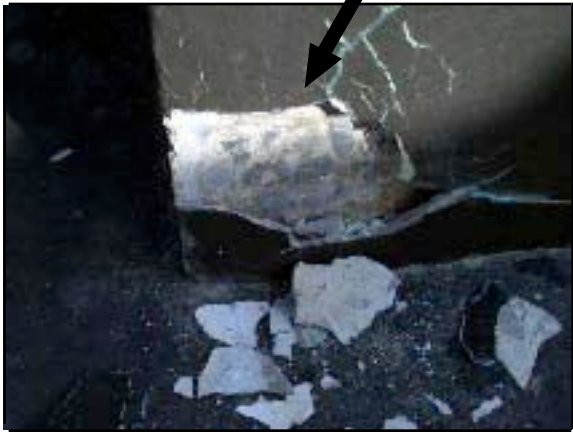
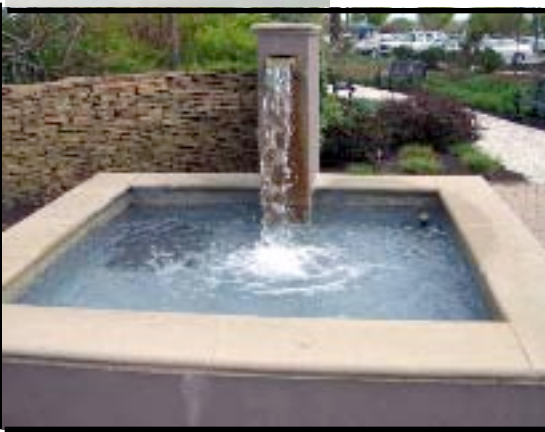
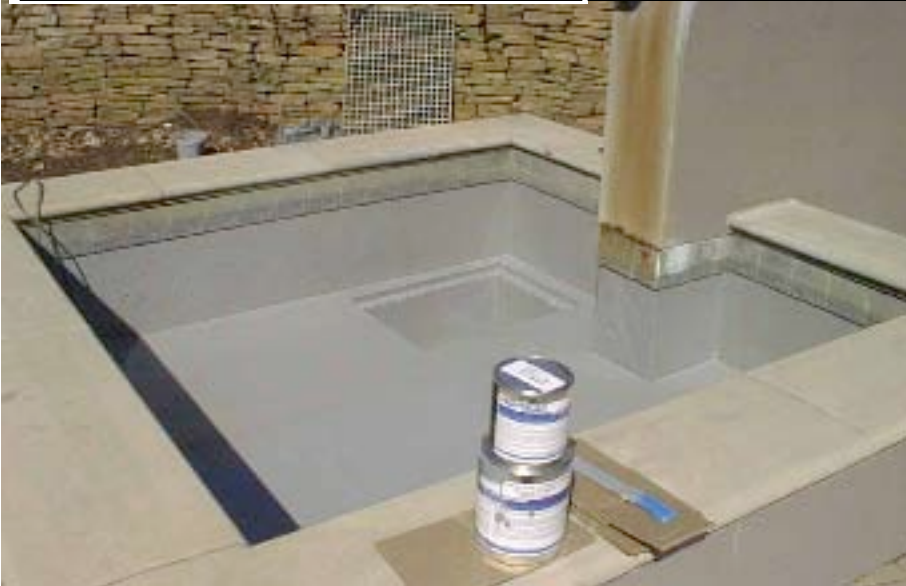
This hospital fountain had sustained much damage from freeze / thaw cycles. **ADVANCED Polymer Repairs** has rebuilt many fountains with long lasting results using years of know how and the finest possible repair products. In this

case, a unique flexible epoxy was chosen as a base / sealer. This epoxy bonds tenaciously to almost any substrate and

will not crack from normal expansion and contraction. Two hybrid polyurethane coats were applied on top to provide UV stability and achieve the color chosen by the customer.
