Project Profile

Casino Coin Count Room

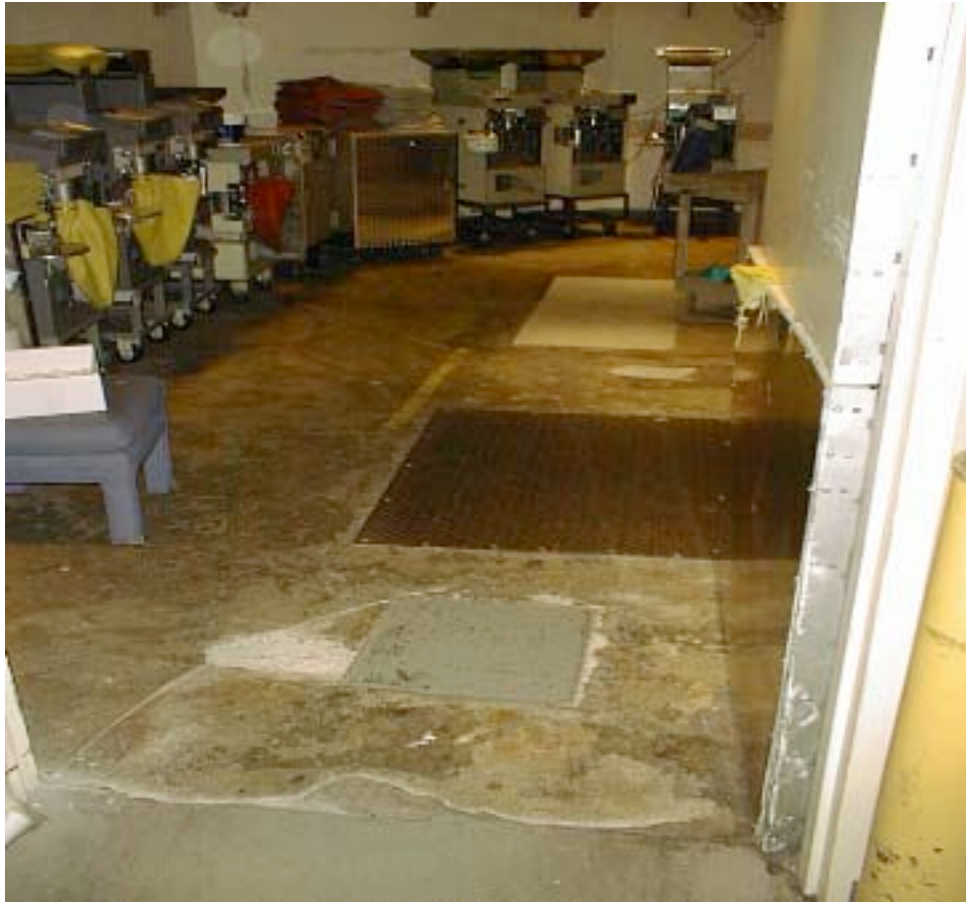
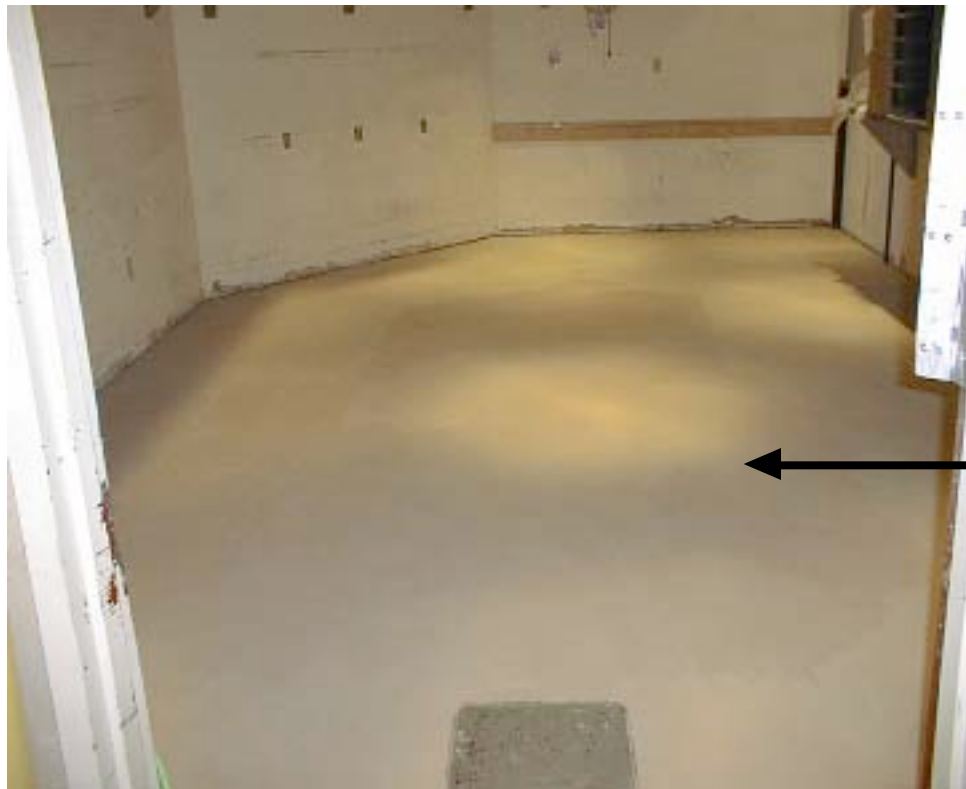
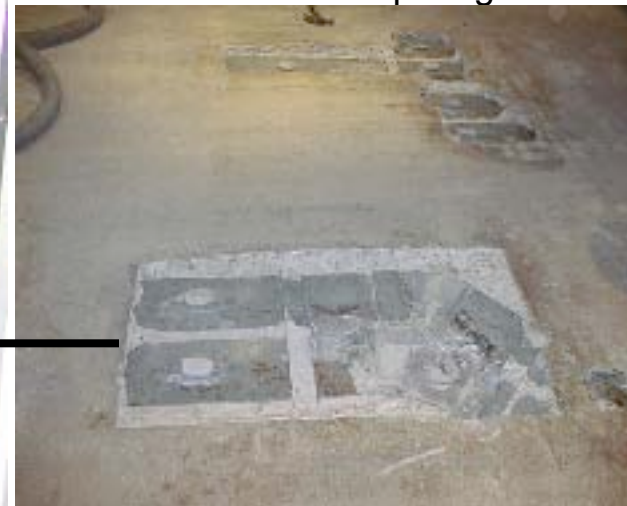
The coin count room in this Atlantic City casino suffered damage from the heavy coin carts - over 2,000 lbs. The area had been repaired several times using conventional, inexpensive products with no success. The casino had to eventually cover the repairs with steel plates. Fearing one of the heavy carts might tip over and injure someone after encountering one of the many pot holes, the casino called in **ADVANCED POLYMER REPAIRS**.

The repairs were carried out in two days using an odorless product which has a 12,000 psi compressive strength.. The casino staff is pleased with their new, long lasting floor system. **ADVANCED** ..has also done similar work on the casino floor in areas where the coin collection "train" causes extensive damage to the concrete under the carpeting.
