# Project Profile

## Drain Trough Sealing

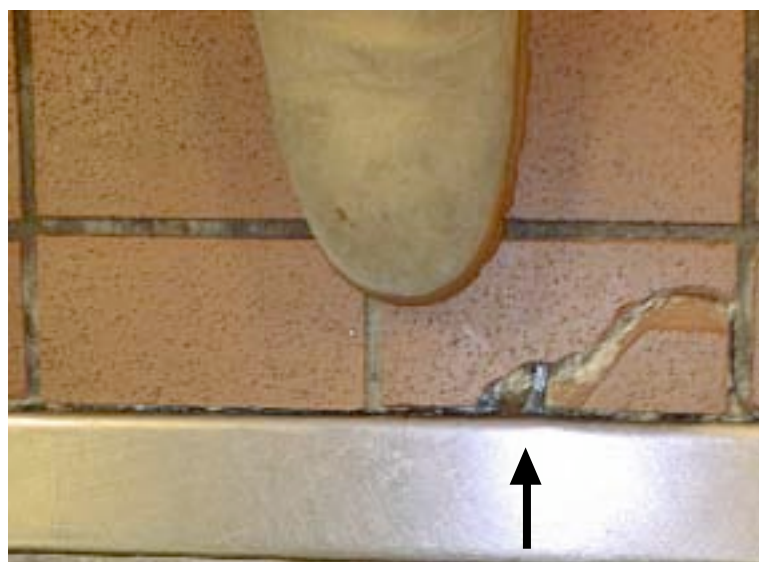
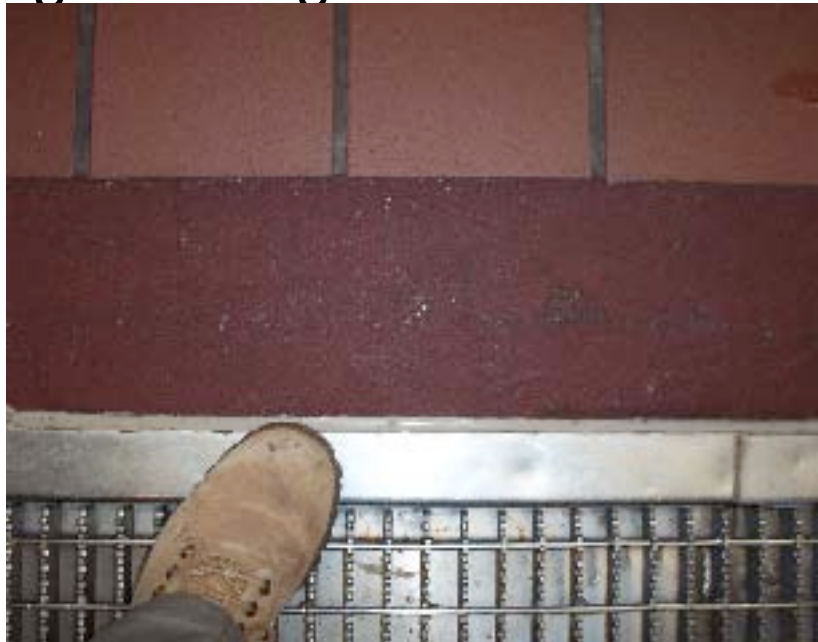
The drain troughs at this Atlantic City casino had attracted the eye of the health inspector due to water pumping from under the tile when stepped on. The tile was being replaced approximately every 6 months and water was finding its way through the floor and onto the casino below. The casino could not find a long term solution to this problem.

The problem was solved by **ADVANCED Polymer Repairs**. One row of tiles was removed and was replaced with a trowel applied concrete repair product in a matching color. A joint was left between the repair and the drain. This joint was then filled with a flexible joint sealer which adheres to the stainless steel drain and to the concrete repair allowing the drain to move without leaking. The leak was sealed permanently.
