Project Profile Thermal Shock in Kettle Line Areas

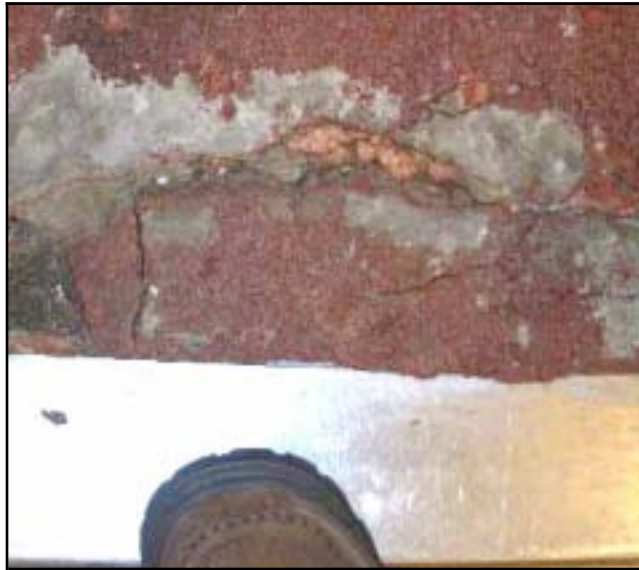
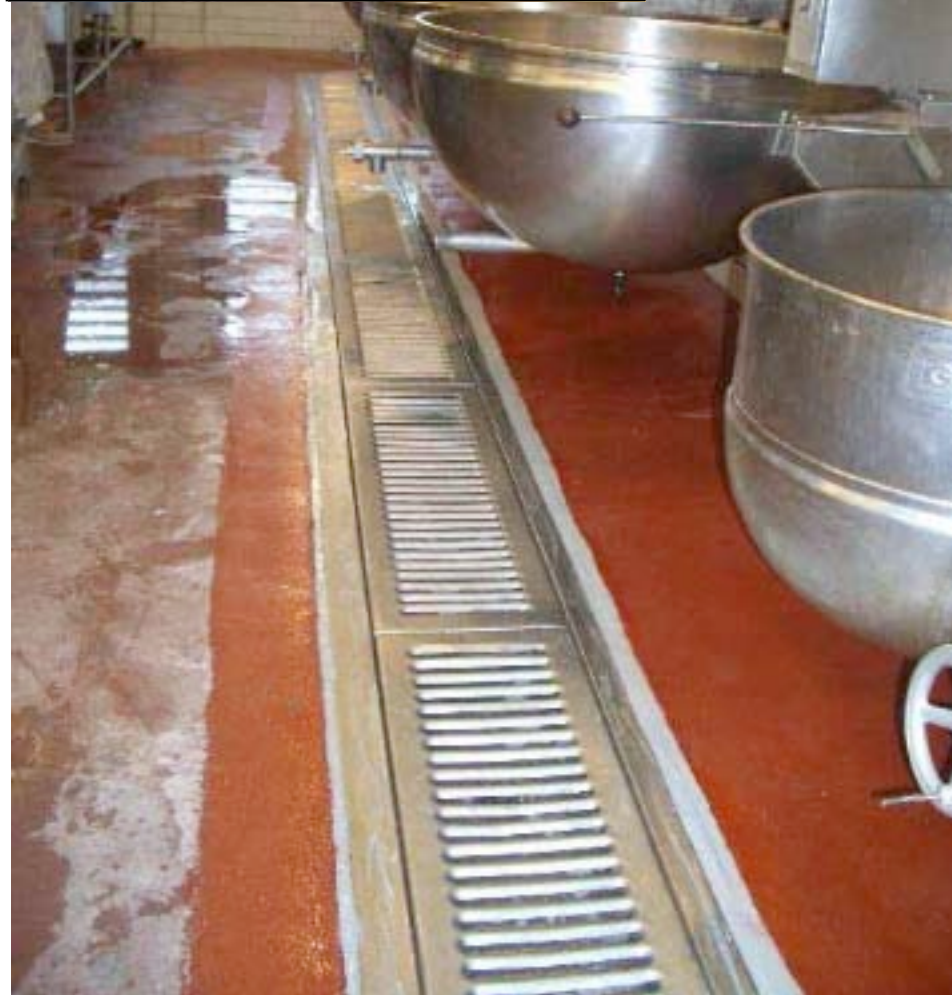
Years of experience dealing with the problems associated with thermal shock and expansion / contraction in kitchen kettle line areas brought this state prison to **ADVANCED Polymer Repairs**. When large amounts of boiling water are suddenly dumped onto a conventional flooring system

the thermal shock and different rates of expansion of the steel drains and masonry floor cause cracks. Water penetrates these cracks and repeated thermal shock cycles eventually cause leaks, cracks and areas of failure.

ADVANCED Polymer Repairs understands these problems and is uniquely qualified to recommend long term and cost effective solutions. This experience makes **ADVANCED** the "safe choice" for all of your kitchen floor problems.
