Project Profile Repair and Protect Trash Compactor Floor

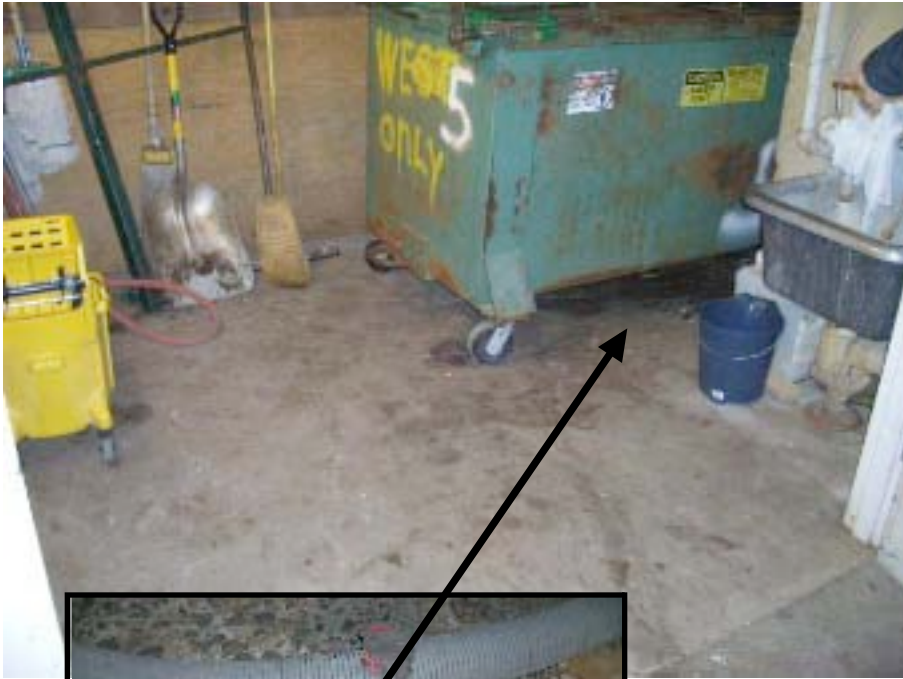
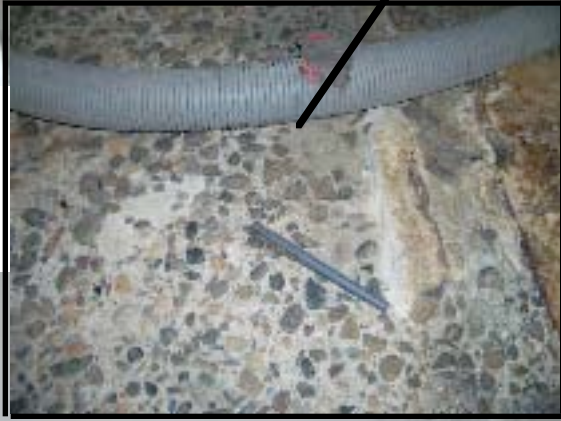
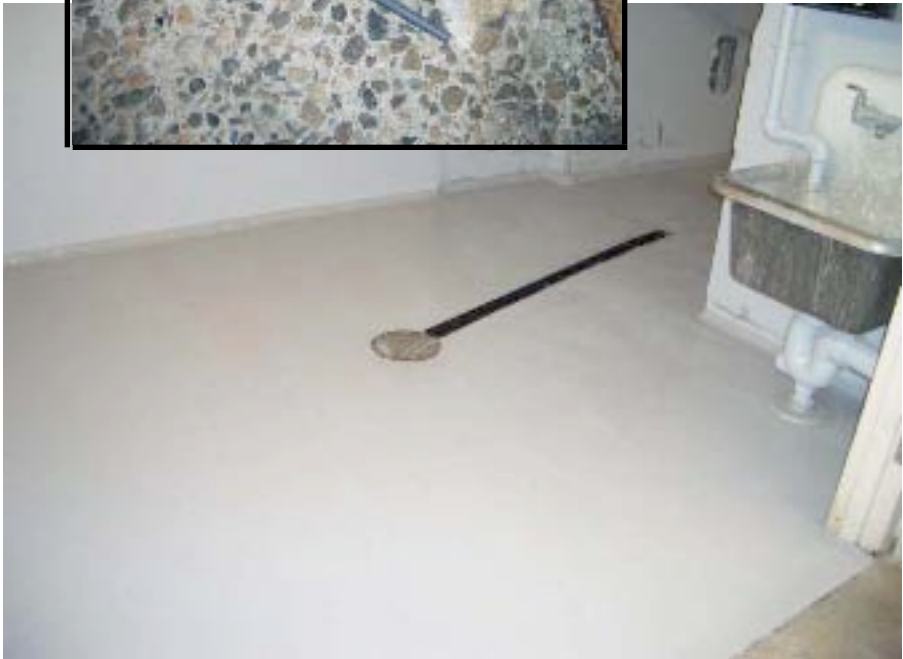
This trash compactor services a 17 story dorm tower at a major university. Years of damage from the heavy dumpsters and chemical attack from leaking trash juices had taken their toll on the concrete floor. **ADVANCED Polymer Repairs** was asked to repair the floor during a brief shutdown of the room to change out the compactor. Working on a tight schedule **ADVANCED** installed a drain under the compactor area and connected it into an existing drain. The spalled and damaged concrete was repaired using a proprietary, 100% epoxy concrete repair system. The entire floor was coated with a chemical resistant system and seamless, epoxy cove bases installed to contain water used to wash the area.
