## Project Profile Concrete Repair, Electric Utility Generator

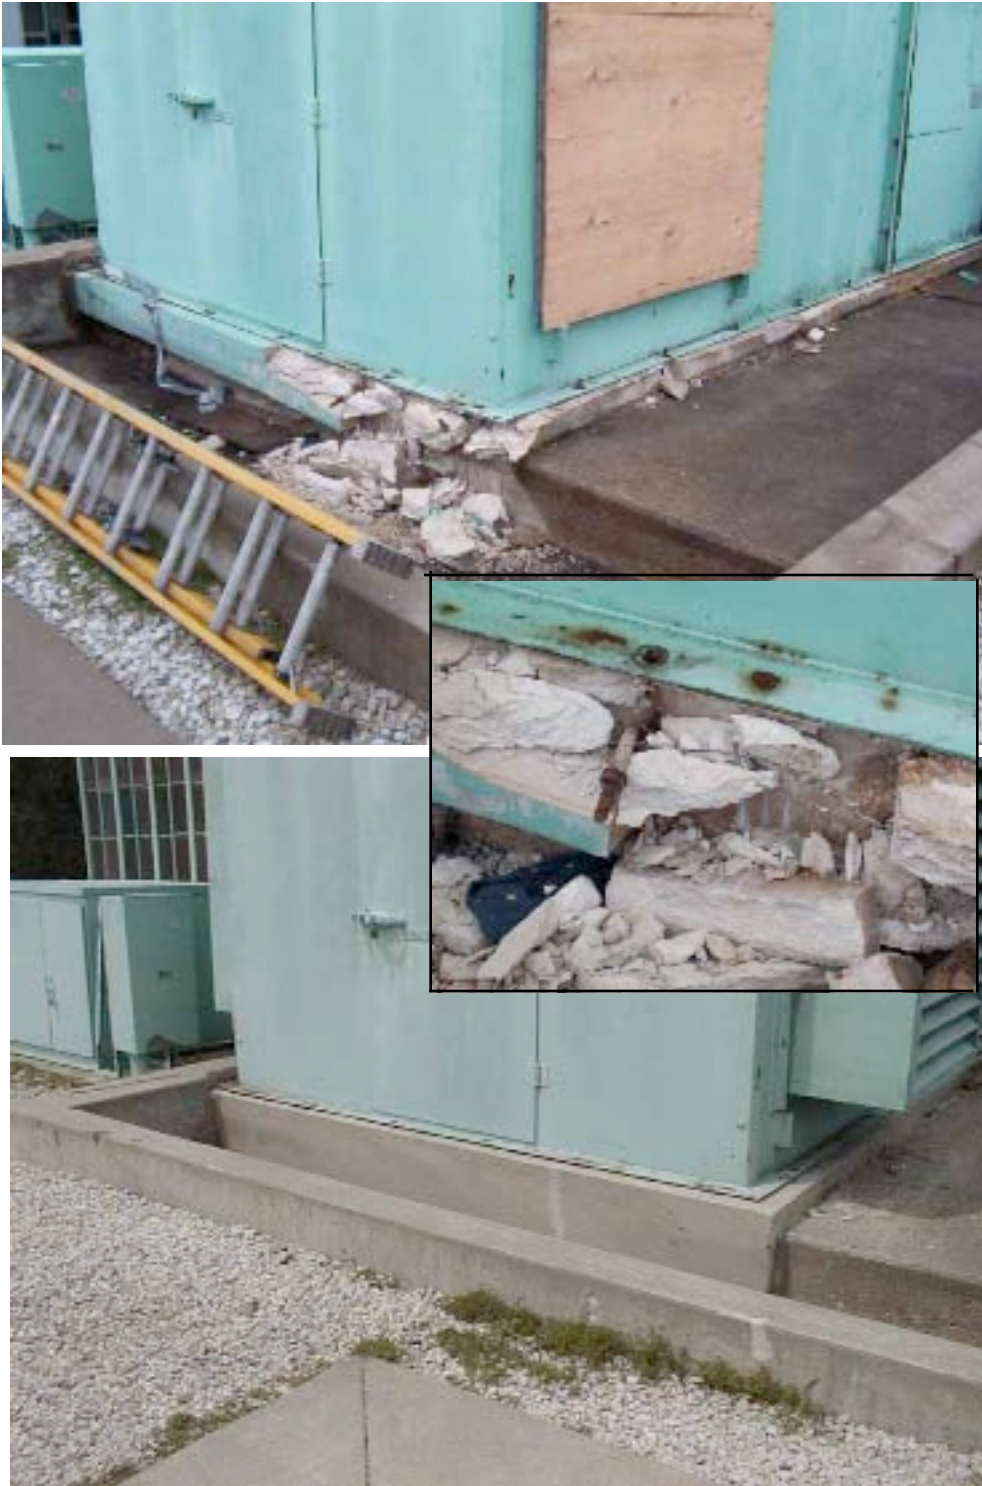
When a contractor dropped the 10 ton containment structure which houses this combustion turbine generator, the concrete footing was severely damaged. Unable to operate the generator and facing lost revenue of over \$100,000 per day using concrete would have shut the generator down for at least a week. The utility called in **ADVANCED Polymer Repairs**. Having used **ADVANCED** on other critical projects, they knew the repair could be carried out quickly. Using a fast curing, high strength (12,000 psi) epoxy concrete repair system, the generator was back on line on the third day.
