Project Profile Corrosion, Air Conditioner / Heater

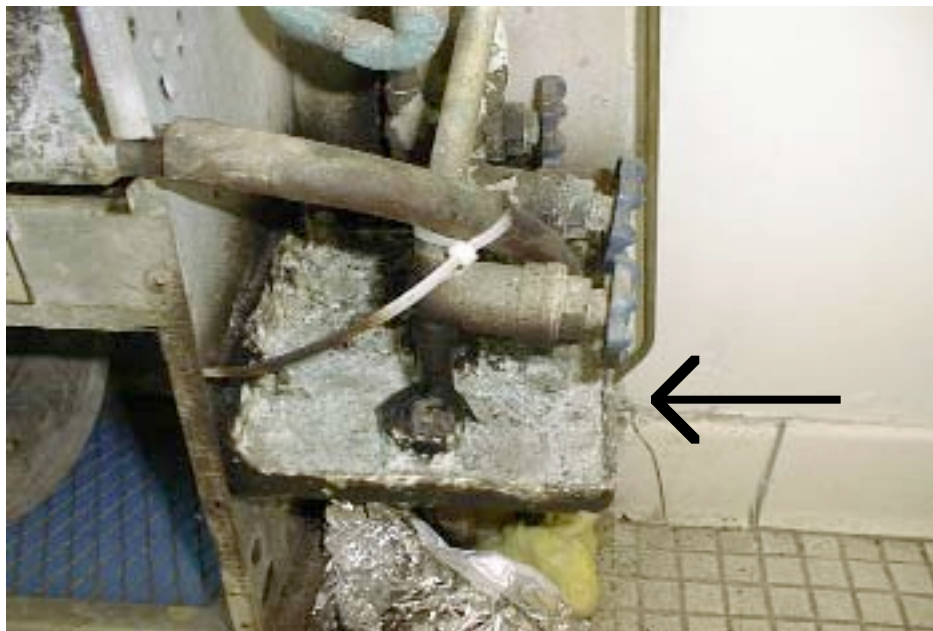
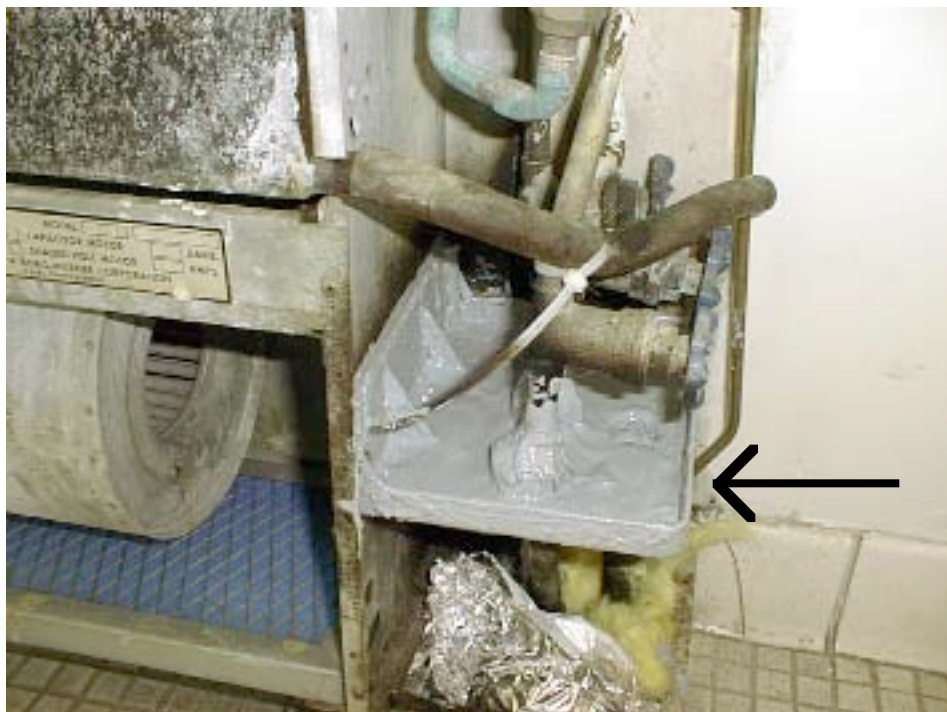
This facility had a problem with their individual room air conditioner / heater units. The condensate pans were heavily corroded and some looked more like swiss cheese than steel. **ADVANCED Polymer Repairs** was called in for a fix. **ADVANCED** has extensive experience in dealing with corrosion in HVAC systems and specified a product which would completely encapsulate the pans, completely stopping any further corrosion. The property manager was able to repair

the units instead of replacing them as they had in the past. Over 500 units were scheduled for replacement. This solution saved the property over \$300,000. The product specified is very easy to apply and is virtually odorless.
