Project Profile

Plastic Pipe Repair, Sodium Hypochlorite Tank

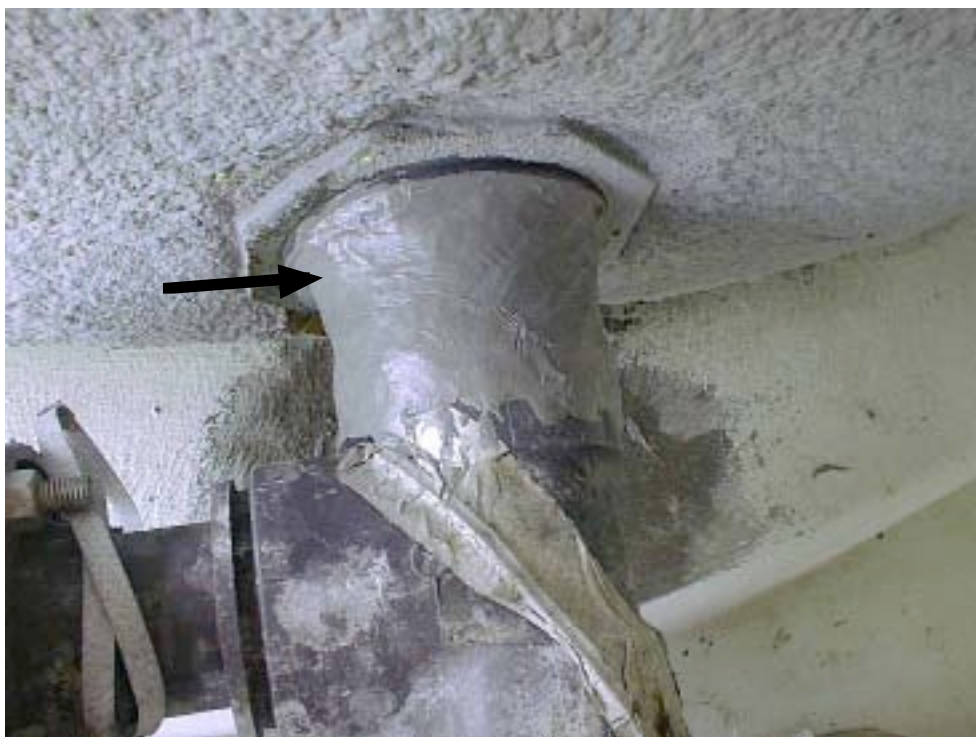
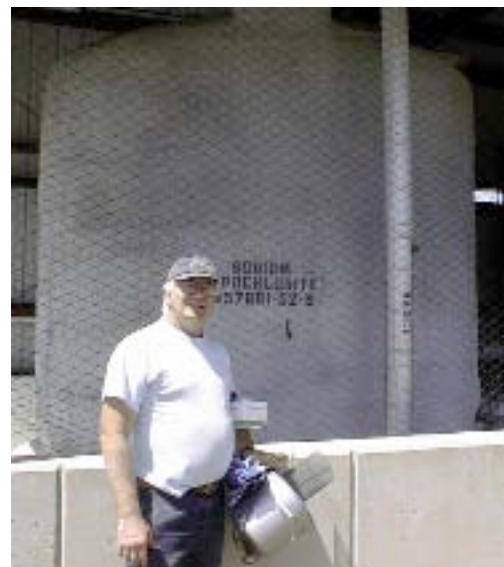
High concentrations of bleach had caused the bung threads in this 5,000 gallon tank to leak. Plastic "welding" held up for only one year. The waste water utility contacted **ADVANCED Polymer Repairs** in the hope that **ADVANCED** had a "magic bullet" solution. A high performance, chemical resistant repair system was specified.

In house staff performed the repairs in less than an hour under the experienced eye of Jim Krasnov of **ADVANCED**.

About \$50 of product saved the utility several thousand dollars in replacing the tank. As of this writing, about 5 years later, the maintenance staff reports "NO LEAKS!"
