## Project Profile Concrete Repair, Decorative Roof Element

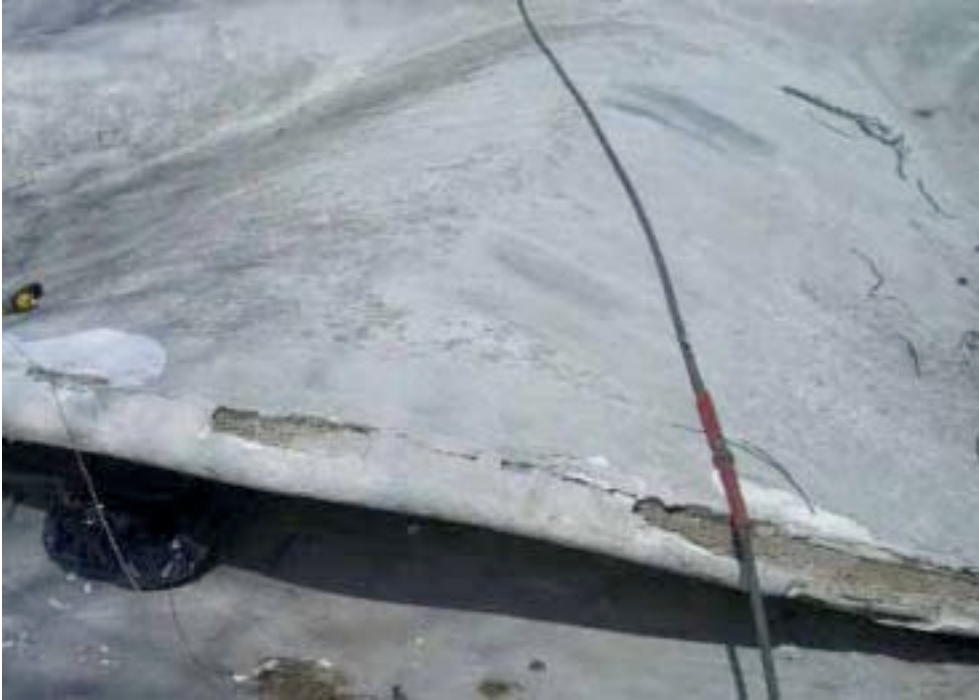
When this elaborate concrete roof started to crack and fail around the edges

Using a unique, 100% epoxy concrete repair system which can be applied up to 6" thick on vertical surfaces and 3" thick overhead without slumping

**ADVANCED** had this roof repaired in only one day.

The repair system chosen was immediately coated with a color matching coating to seal the concrete adjacent to the repair.
